The following Good Safety Practices were developed from the Innovation in Safety Award submittals.

2021 Reports

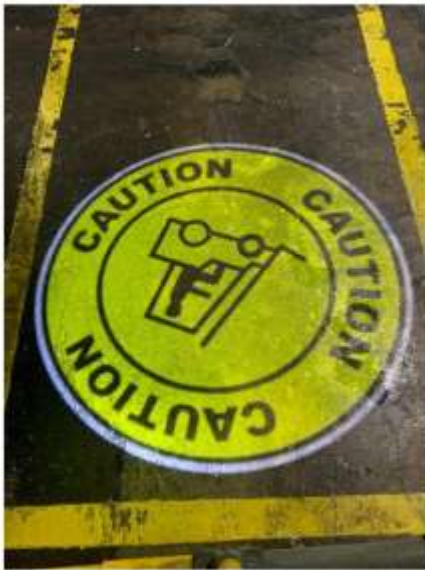
We have installed 2 projectors that project signs which rotate onto the pedestrian travel path to increase awareness of forklift traffic.

In two areas of our facility, we purchased and installed Safety Cast Virtual overhead projectors which shine a rotating safety image down onto the floor of pedestrian walkways. These images alert/remind employees of the hazard of Forklift Traffic in the area.

In a collaborative effort with Management, IE's, Maintenance employees, and the safety Department, Safety Cast Virtual projectors were purchased, and installed, to increase awareness of potentially hazardous intersections in our facility.

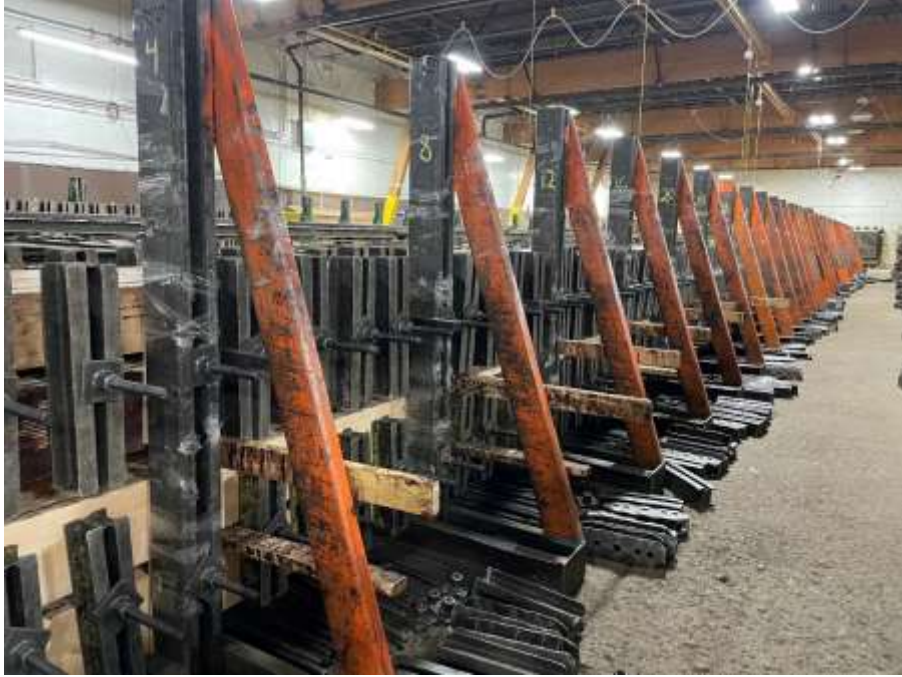
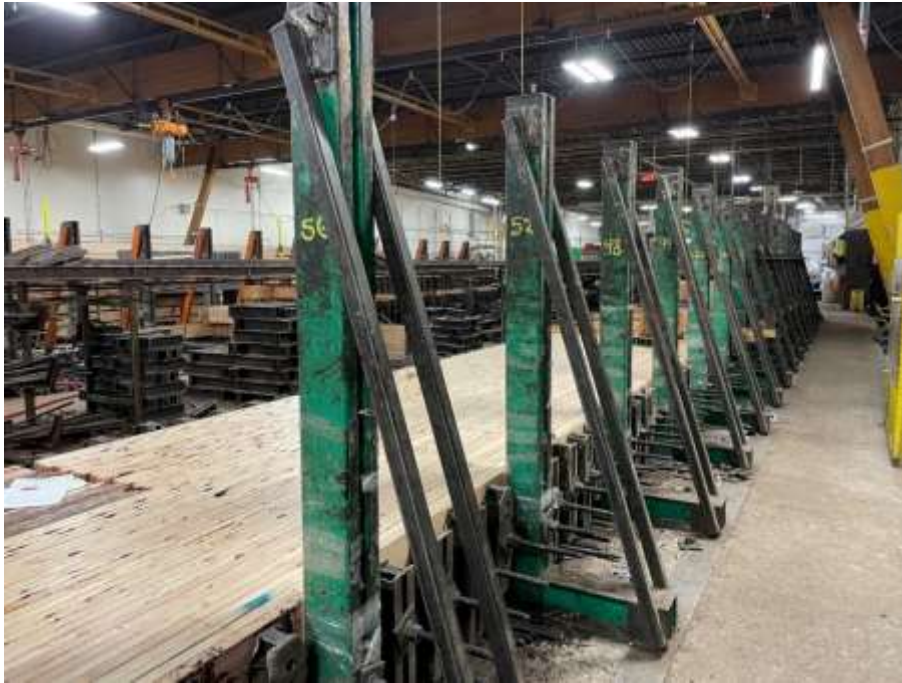
The plant created a reverse camber book, an orange binder, for the scheduler and layup department to glue all beams in the south rack with the opposite lamination layup as the north rack, which eliminated the need to flip every beam from that rack. The annual piece count from that rack that was previously flipped by hand and hoist prior to feeding into the planer is between 11,000-15,000 beams. The plant painted the two racks, north green and south orange, to identify which rack utilizes the corresponding camber book of the same color.

The plant formed an action team consisting of an operator from the layup department, Quality Coordinator, Controls Engineer and Industrial Engineer to calculate the reverse camber values for the operator who cuts camber blocks. The team created two books; the first was to replace the existing camber book with a green binder with green pages, the second was an orange binder with orange pages for the reverse camber layups. The team then painted the corresponding jigs green and orange to help the associates in the layup department easily and clearly identify the correct camber and layup combinations.

Overnight the plant was able to eliminate the need for an operator to hoist and flip every beam laid up in the south rack. This removed the operator from being in the line of fire of a potential hoist failure and the result of the falling beam.

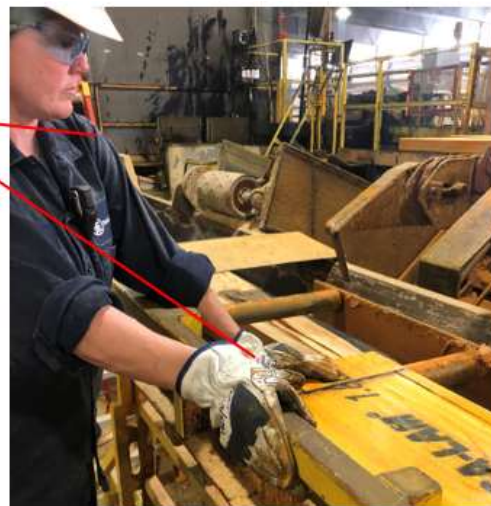
Stress points

Boards have to manually pushed down the rollers, potential for abrasions, strains and hand injuries.

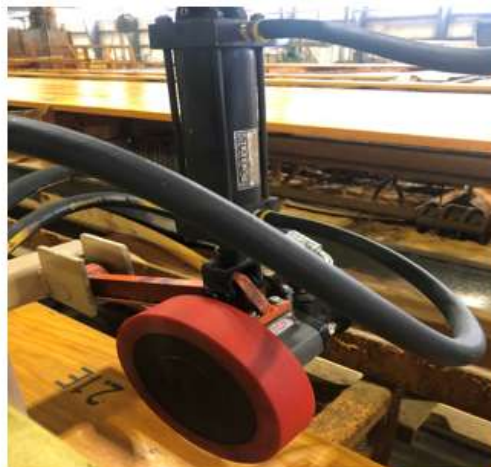
Hydraulic motor with adjustable speed control Mounted on a pneumatic Cylinder to hold pressure On the boards.

Controlled by two switches that were added to the control panel.

Plant safety committee members from our sawmill team brought forth a concern in one of our committee meetings. Team members were having to use significant force to move the larger sized boards down the reman roll case to be processed. The safety team wanted to do something that would reduce or even eliminate the risk of strains and abrasions from having to push boards manually. The result was a small Hydraulic system with a pneumatic cylinder added to the roll case that operators can use to move the board along the rollers basically without touching the boards.

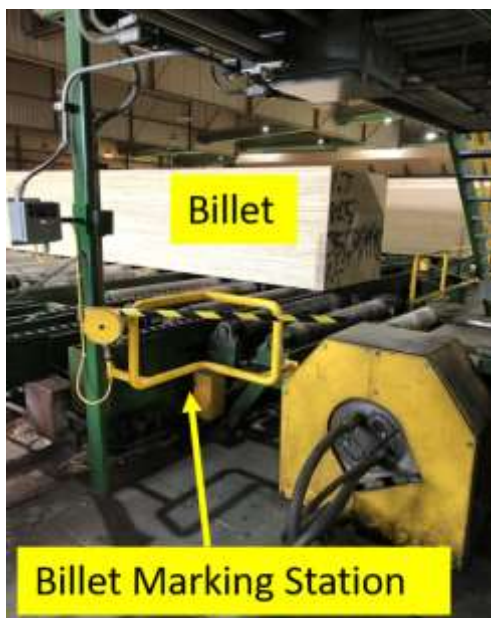
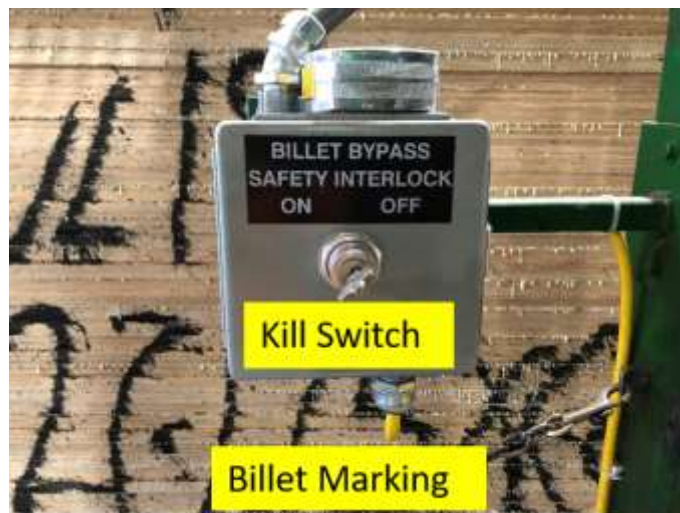
The updates to the job procedures included no longer marking the billets from the East side of the Cold Press. Instead, we created a Billet marking station on the opposite side of the Cold Press (West side) beneath an elevated walkway and is now marked after the Billet leaves the press via the transfer chains. Not wanting our operator exposed to any moving parts, we installed a guard rail surrounding the marking station thus keeping the operator at a safe distance from the transfer chains. Additionally, we created a redundant safety system which includes the installation of a proximity arm and kill switch. Both completely lock the transfer chains from moving when activated. To enter the Billet marking station, the operator must lift the Proximity arm, which locks the transfer chains, as well as activate the kill switch prior to making mark on Billet. The kill switch was installed to ensure there could not be an accidental activation of the transfer chains if the proximity arm closed unknowingly.

The innovative/novel solution we are submitting occurred within our Layup department. Within the layup department, we have a 67-foot by 5-foot Cold Press. Panels of PLV blanks, that have been jointed together to a specific length, are transferred to our Layup Rack and stacked/glued together to again, a specific dimension. From here, these stacked PLV panels or Billet, is transferred to our Cold press where hydraulic rams compress the billet at 2,300 PSI for approximately 30 minutes. While the Billet was under pressure, the Cold Press operator would mark the Billet with ink which includes information such as Date the product was finger jointed, press load #, grade, thickness, and length. The operator would accomplish this by physically breaking the plain of operation of the machine with approximately half their body on the East side of the Cold Press. This unfortunately had gone unrecognized and had become common practice. Actions that followed included updating the procedure for the task, installing additional guarding, a Proximity arm and kill switch.

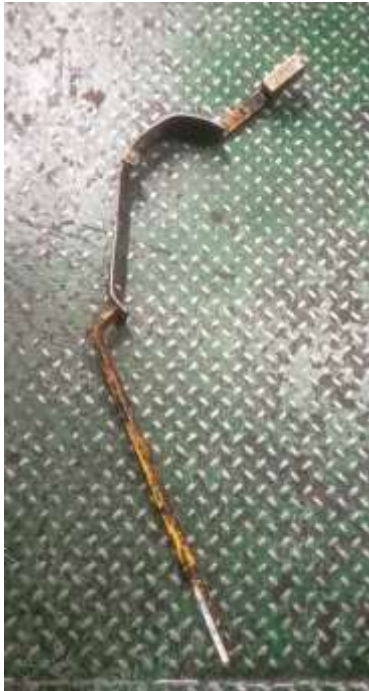
Photo 1: ¶
¶ Secondary Hook Device Added ¶
¶
¶ Pendulum/Core Drive Safety Hook Engagement ¶

Photo 2:
Secondary Safety Hooke

The secondary pendulum/core drive safety device was developed to provide a more robust measure to insure the COE safety hooks (hook lock) remain in position (photo 1) and do not unintentionally come unlatched. The device acts as a blocking wedge to prevent the safety hooks from coming loose and falling.

It was developed in response to an incident that occurred when a positive engagement of safety hook locks failed on a core drive. All Boise lathes were required to install a secondary safety device to prevent risks. The secondary device that was most common was a chain or secondary hook, both of which had potential downfalls. Our maintenance superintendent was not comfortable with the thought of a chain that could fail if the lathe was unintentionally energized. The COE safety hooks are engineered to prevent the core drive/pendulum from moving if engaged (photo 2). There are two hooks, the second (photo 3) being a redundant safety device. The intent of this device was to utilize the safety hooks that already exist and create a way to prevent them from coming unlocked. This device accomplishes this feat. The concept was introduced to the operators and was well received due to its simple design.

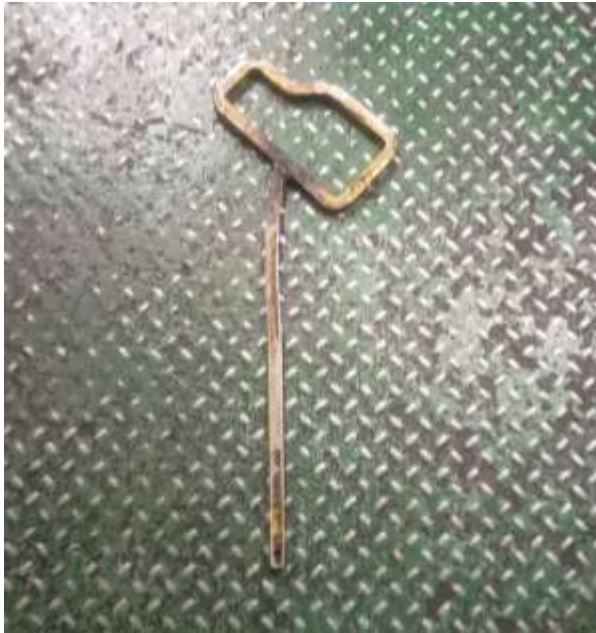
Photo 3:
Redundant safety device

This hook lock device has eliminated the potential risk of the safety hooks coming loose and dropping the pendulum/core drive. All other secondary safety devices that could adequately support an energized system would not be feasible. This small light weight design utilizes the existing system and provides a confident measure for locking the safety hooks.

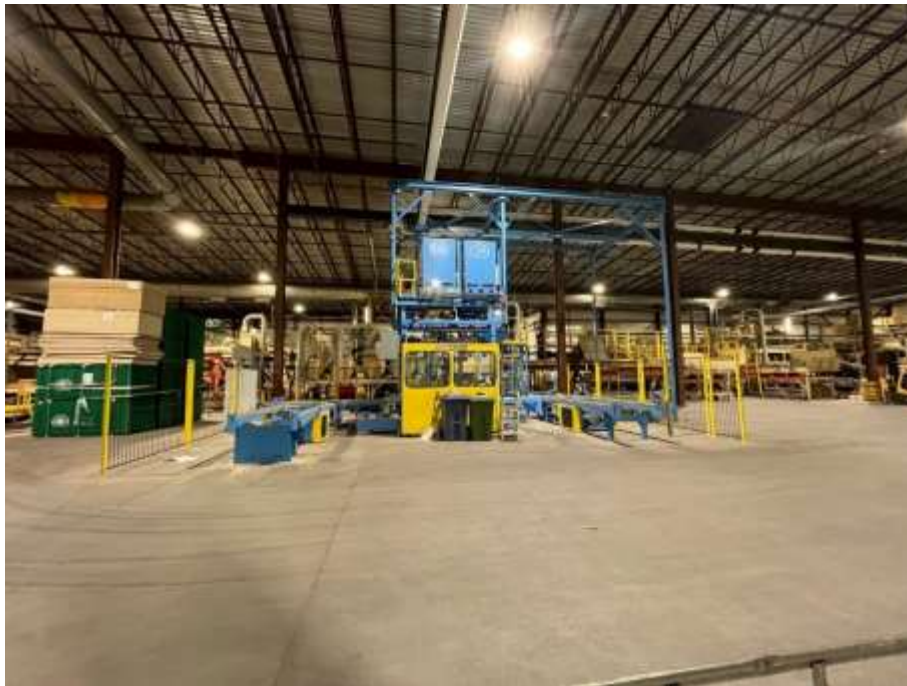
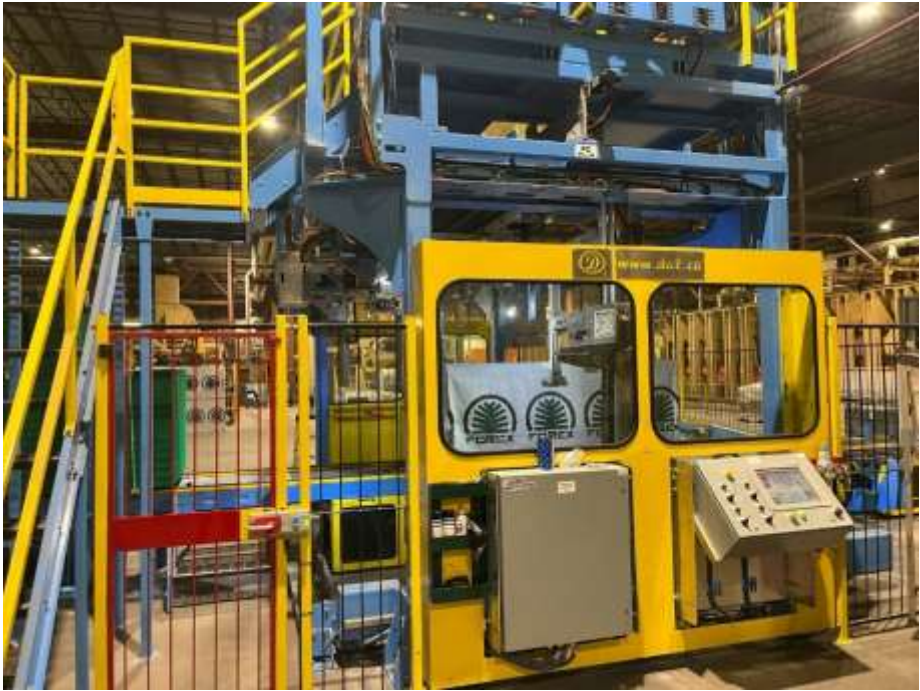
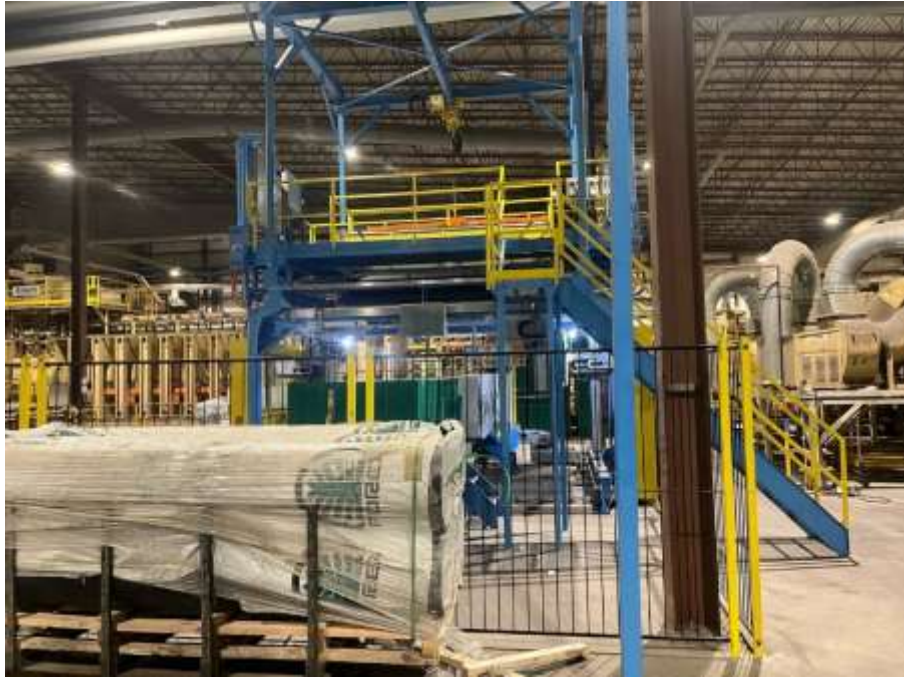
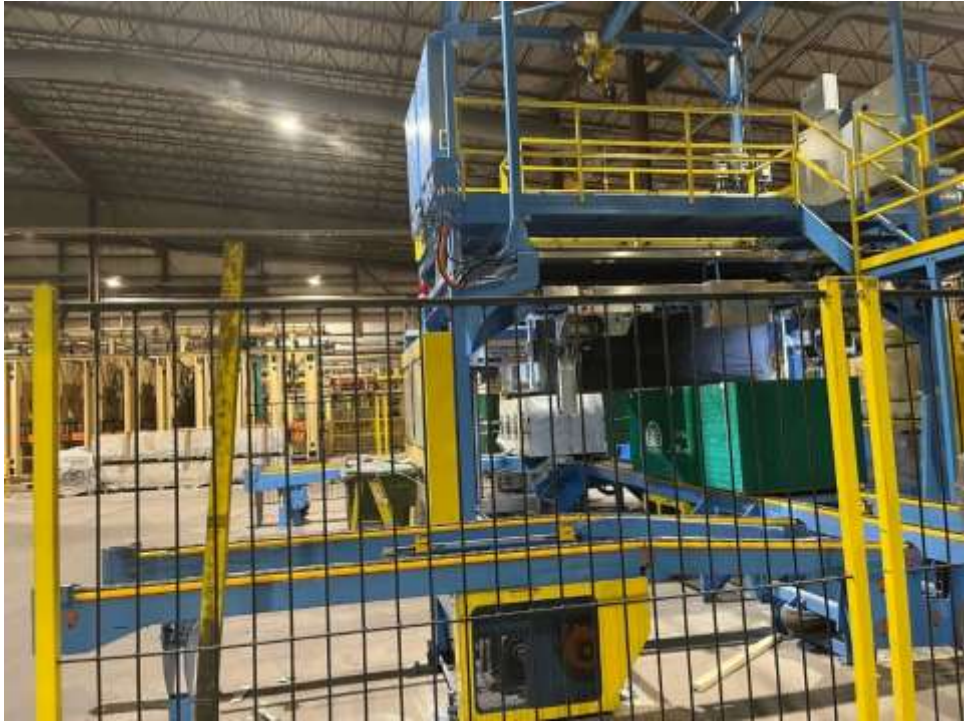
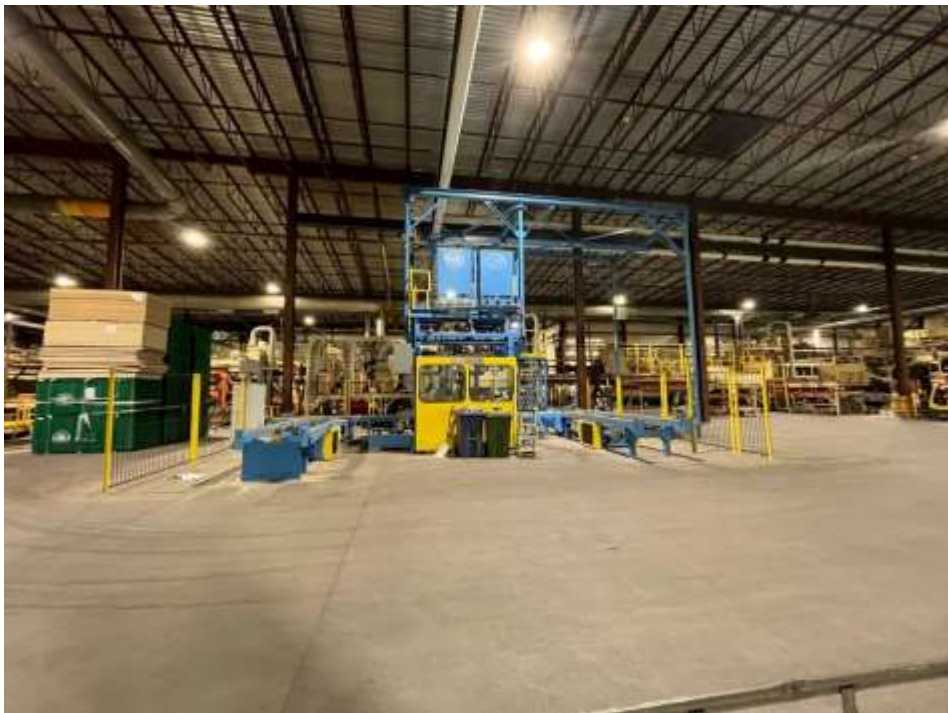
DO2 Packaging System

The DO2 packaging system is an automatic bundle packaging machine. The DO2 is equipped with conveyors that bring and transport the wood bundles from the entrance to the exit of the packaging machine. This new machine is equipped with several robotic arms (4) to wrap and staple the bundles. It also has a system for printing labels directly on the paper wrap. We also have an overhead trolley that changes the paper rolls when they run out.

We evaluated this opportunity in January 2021. After several incidents causing minor injuries and a lot of lost time, we asked ourselves the right questions and thought about the best solution for the health and safety of our employees. From there, the idea of implementing the DO2 automatic packaging machine was born. The process went quickly with the project team that we put in place with the supplier, we were able to install it in October 2021.

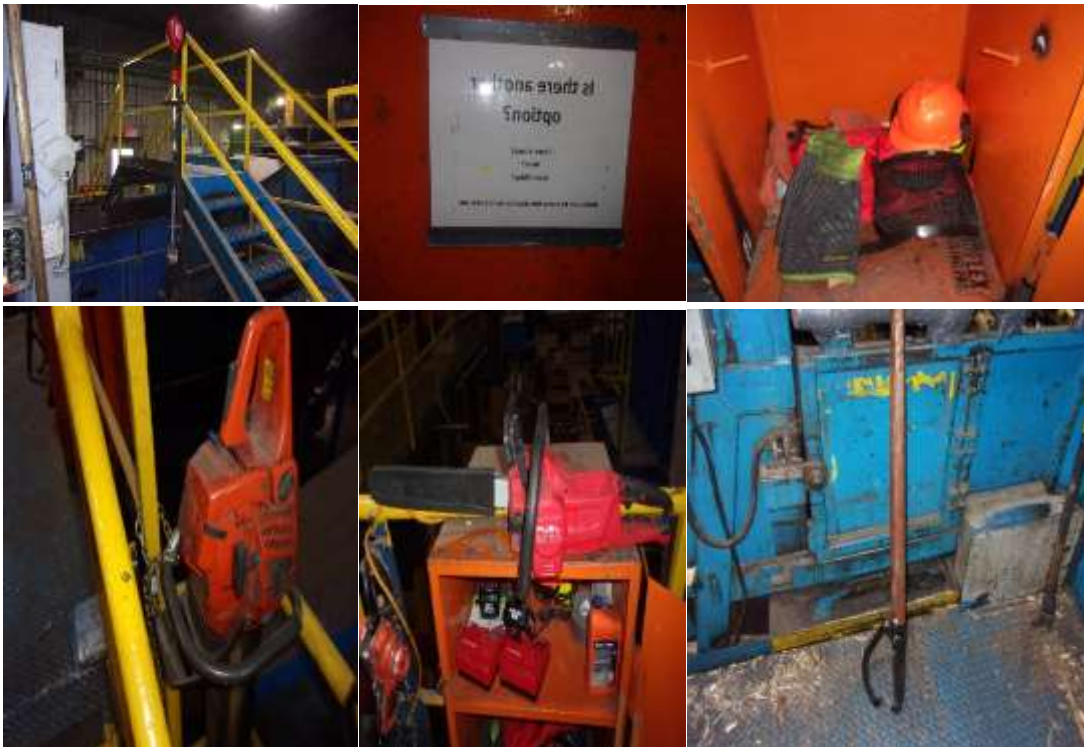
When looking at chainsaw safety statistics we see that a high number of injuries happen during the starting process. One thing that we have come up with to eliminate that risk is to use electric chainsaws that don't need to be started. We ordered a Milwaukee 18v battery operated chainsaw and a Milwaukee 18v battery operated pole saw. The pole saw allows us to do most of our wood cutting from the deck outside of the equipment, this helps to minimize trip hazards, and gets the operator away from the chain on the saw. Some other things that we have done to improve safety around chainsaw use is to lock all the saws up and have a supervisor present before getting them out and during use, we have also asked that we look for alternate methods of removing stuck or crooked logs before getting the saws out, we have pike poles, cant hooks, come a longs and hoists available to use instead of a chainsaw, we've asked the supervisors to be present during any situation that might require the use of a chainsaw to ensure we are looking for other methods before we unlock and use the saws. We still have gas saws available for big logs if needed, but they are kept locked up along with the Milwaukee tools.

By implementing this new chainsaw safety program we have seen far less chainsaw use, employees are looking for other ways to move/remove logs with out the use of chainsaws. With the addition of the pole saw we are also seeing the amount of time spent inside the machines has gone down, now we have an option for cutting small logs with out entering the slasher deck or debarker where fall potential and trip hazards are very high, also the battery operated chainsaws are a much safer option than the gas operated saws because we’ve eliminated the risk of injury while starting them, also the gas saws are much heavier and require handling and storage of gasoline.

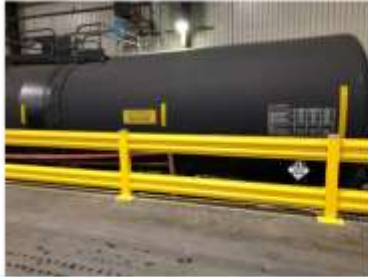
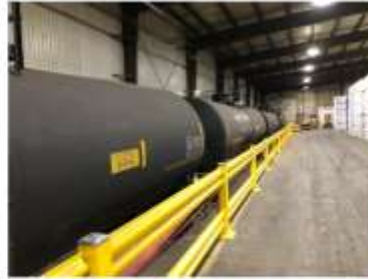
- Lack of barrier on leading edge

Solution Three. This report was presented to the entire company to promote prevention of similar issues in other LP mills. We have had multiple mills already in contact with Newberry looking to install a similar barrier.

This third solution is also hazard elimination. We have never had a permanent barrier along our train bay corridor, this was identified as a risk for forklift traffic (there is roughly a 4' drop to the tracks). Our new shipping route also doubles the amount of traffic that passes near the train bay area. While the project was being planned/designed for an engineered barrier we had a lift back into the bay and fall against a railcar (see report below). An engineered barrier is now in place that will not only protect forklift users, but also protects our pedestrians that use that bay for offloading rail cars.

The train bay barrier was put in place in Dec. 2021. The elimination of that hazard was an immediate benefit. This solution was shared LP wide on our bi-weekly safety call. Multiple other facilities have now shown interest in installing a similar barrier.

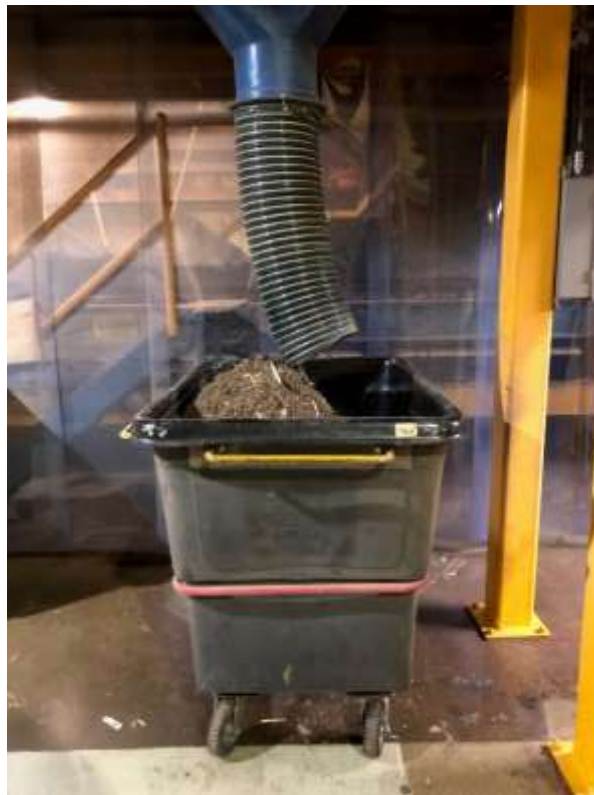
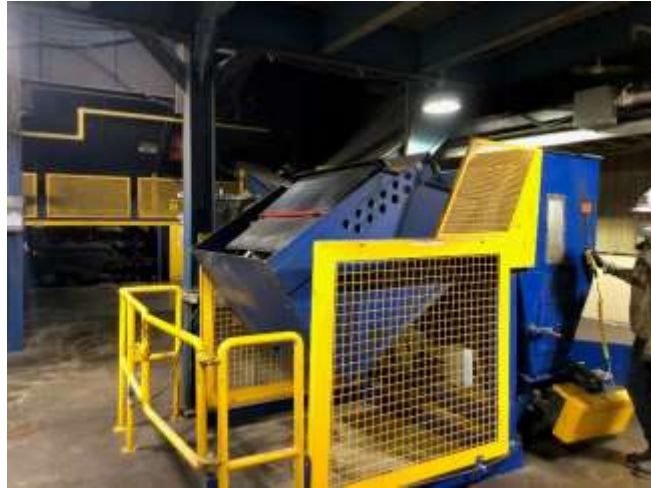
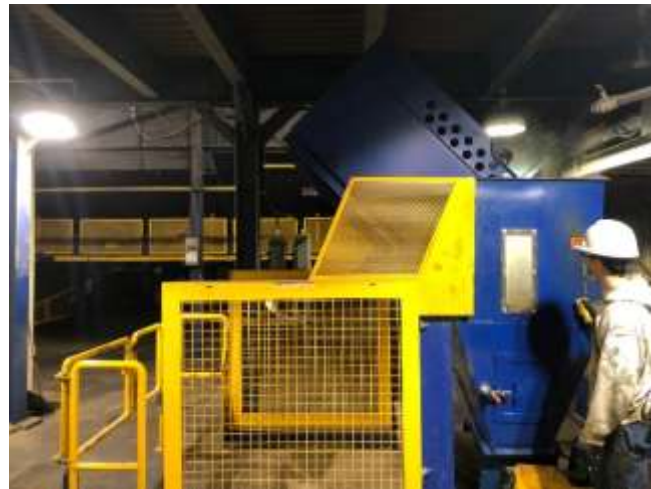
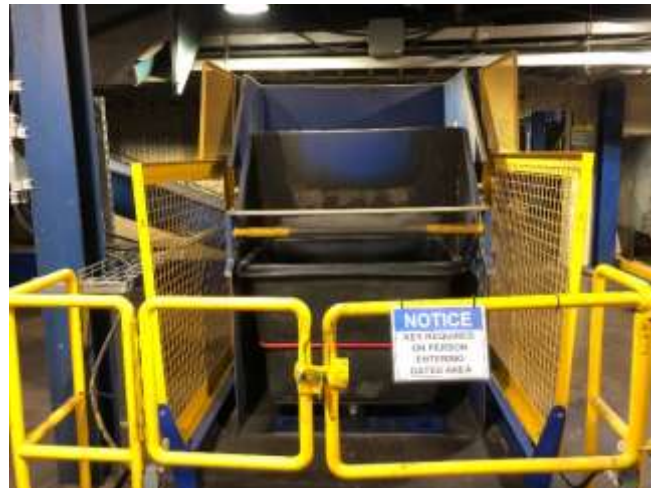
An automatic tote dumping operation was implemented so operators could allow equipment to take on the burden of heavy lifting and keep operators from exposure to associated environmental hazards. Once dumped, the material is then conveyed into a separate clean-up conveyor and combined with other normal process material.

Various operators around the facility have had to handle totes that collect material from conveyor pulleys, conveyor transfers and other collection points. Totes can weigh up to a couple hundred pounds and would be required to be manually tipped over for dumping where mobile equipment would come and collect the material. Tipping/dumping was a hazard for injury due to the weight of the totes. Additionally, operators would have to move the totes through exit doors, sometimes with high negative pressure, exposing them to temperature extremes and other environmental hazards to tip/dump the totes. This activity would take place up to 8 times per shift for some operations.

Departments collaborated, including maintenance, electrical, engineering, operations and safety, to conceptualize, design, and install the equipment.

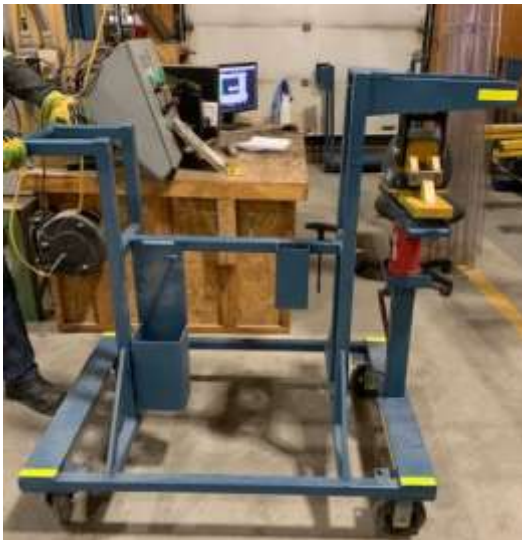
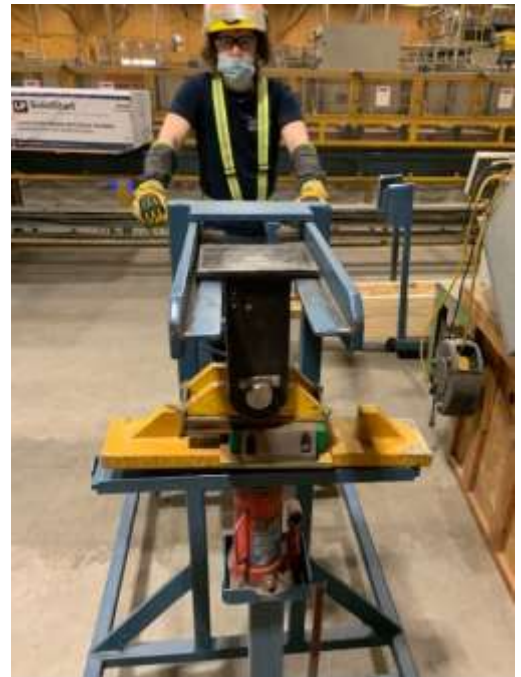
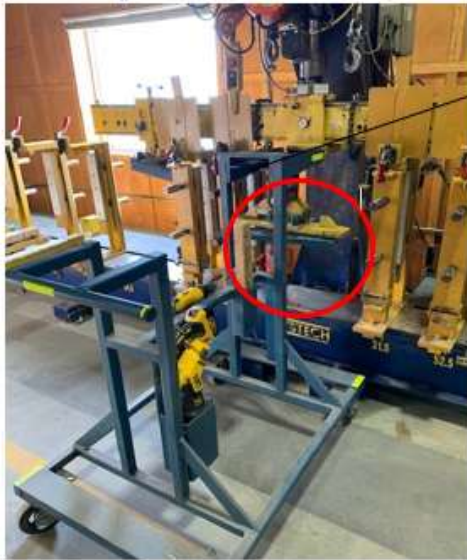
Trolley has wheels so it can be moved easily. It is right the height needed to slide the loading head from the bench test to the trolley (or vice versa).

So the loading head is never on the technician hands. Technicians no longer has to force by themselves. There isn't any risk to drop the loading head or to crush fingers while manipulating.

The trolley is placed right above the bench test.¶
 The loading head can be slide right on the trolley.¶
 ¶

Following a near miss (drop the loading head on the floor due to heavy weight + finger crushing hazards) on this procedure, the mechanical supervisor had the idea to develop a trolley so nobody has to take the part in his hands. He designed on cad his idea then he shared it with the team (lab technician, supervisor, mechanical chief). Everybody loved his idea, so we put it in manufacturing by our mechanical team. Conception started in September 2021 and by the end of October 2021, trolley was in place and the new standard operation procedure was in place.

As soon as the trolley was in place it has given immediate results. Risks are completely eliminate since we do not need to put hands for manipulation and the piece can be slide on the trolley instead of lifting it. risk of entrapment have been completely eliminated. There isn't any coactivity, since technician can do it alone. The trolley also improve the time necessary to do the job.

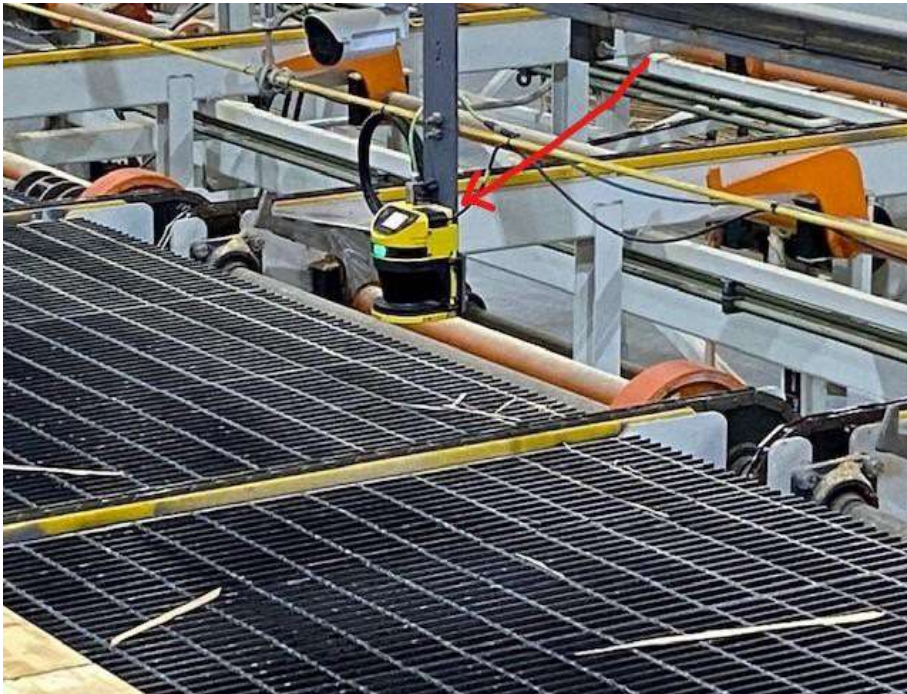
One of (2) 270 degree LOTO safety lasers mounted 6 inches from the grating

The solution that was developed and implemented was the installation (2) 270-degree lasers to allow a much more efficient way for team members to lock out the equipment prior to inspecting LVL billets. The goal was to reduce the billet inspection time per billet while still locking out the inspection deck per OSHA LOTO requirements. The project was a success and has now allowed the inspection personnel to exponentially increase billet throughput in a 12-hour shift. Additionally, (10) Axis 4K cameras were added on the inspection deck infeed and outfeed. The (10) 4K cameras feed monitors are located at the inspection deck operator station. The inspection deck team members can now see things at their workstations that were impossible to see before without having to take extra time to inspect the billet. The 4K cameras reduced the number of times team members had to walk out on the deck by 75%. Prior to the LOTO laser eyes the inspection deck team members would have to throw a LOTO disconnect several hundred times each shift to inspect billets. If a hands-on inspection is required, team members can simply push a button, open a gate, go out on the deck and inspect the LVL billets, and return to the inspection operator station when done and push a button to start the line back up. Before commencing the new process, OSHA was called to the plant to review the laser LOTO methods being used and found that these methods were consistent with requirements by OSHA in the LOTO regulations and therefore met all LOTO criteria required.

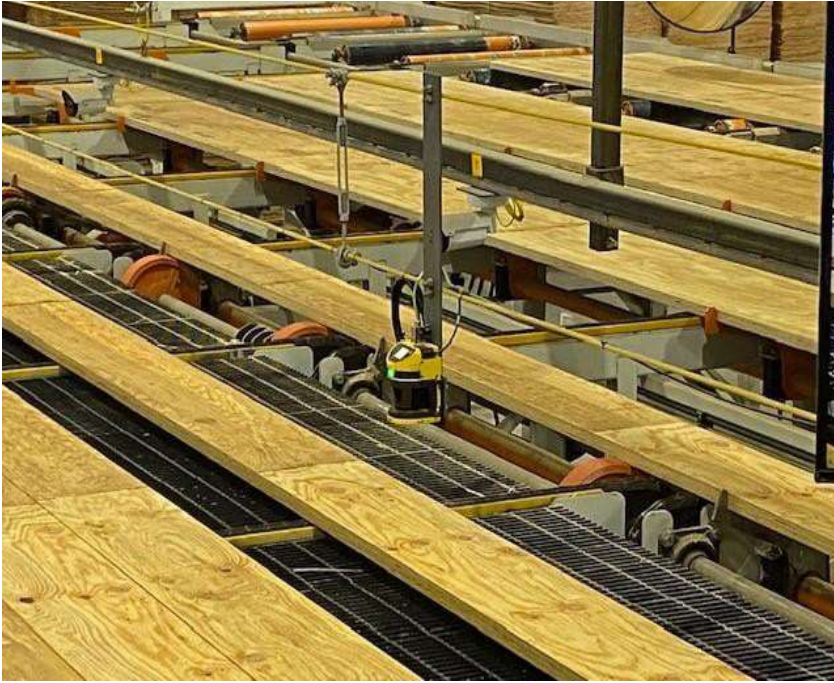
The safety LOTO laser scanner placed high enough off the inspection deck so it will not get false readings from the LVL passing by. However, the lasers are low enough to detect a team member even if they are laying on the grating.

The Safety laser LOTO innovation was developed by members from the maintenance team, plant management, and engineering. The process was introduced to the Regional Safety Manager where it was examined and reviewed for effectiveness. The laser LOTO project was scrutinized heavily to ensure that it met the OSHA requirement for the “Control of Hazardous Energy” (LOTO). Once approved at the Roseburg Corporate Safety level, South Carolina OSHA was invited out to the plant to witness the Safety Laser LOTO Project in action during normal production scenarios. OSHA approved the Laser LOTO stating that it met all the requirements for the Control of Hazardous Energy as required by the LOTO standard.

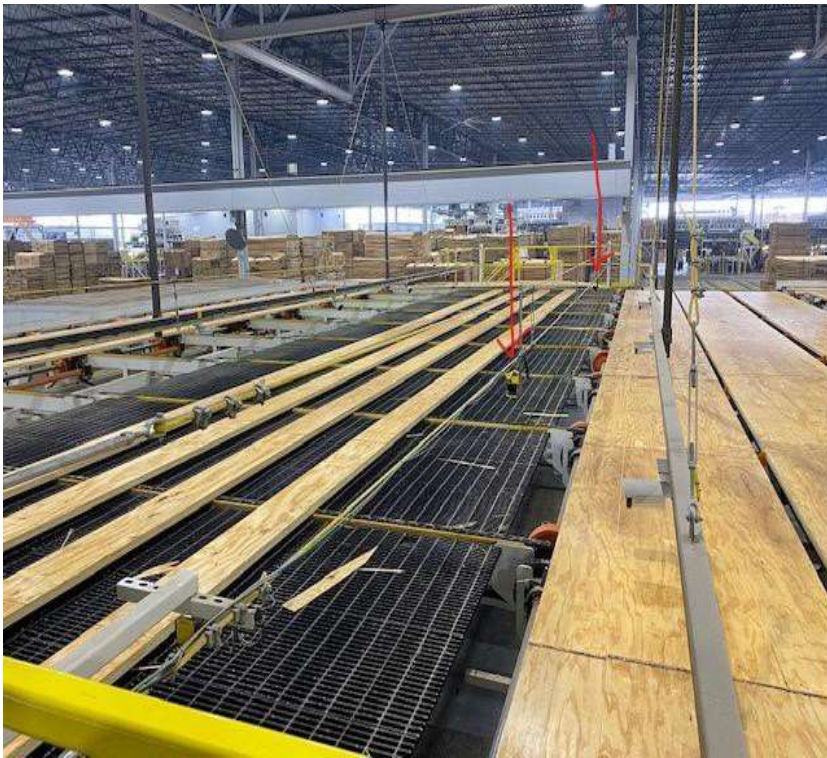
The inspection deck in the above picture depicts the area where team members must walk out to inspect the LVL billets. The safety LOTO lasers detect the presence of personnel and eliminate the line from being operated.

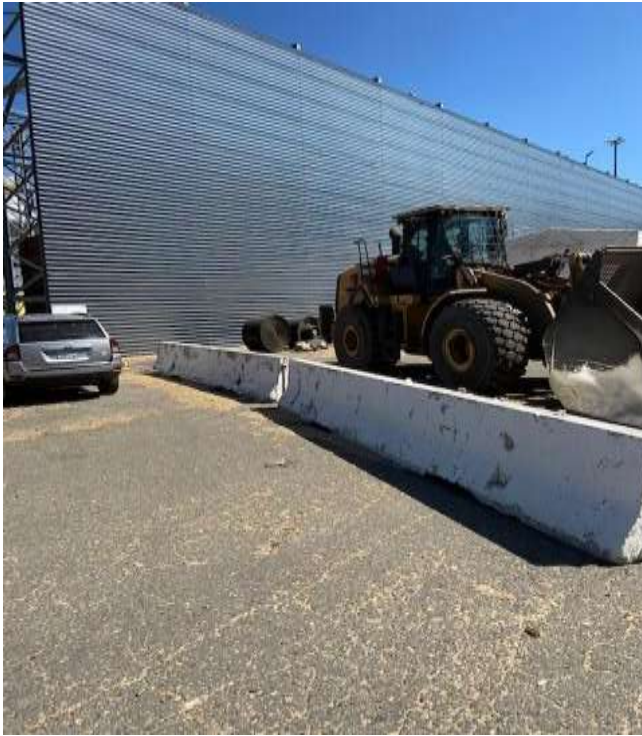
Example of barriers put in place to eliminate drive through traffic

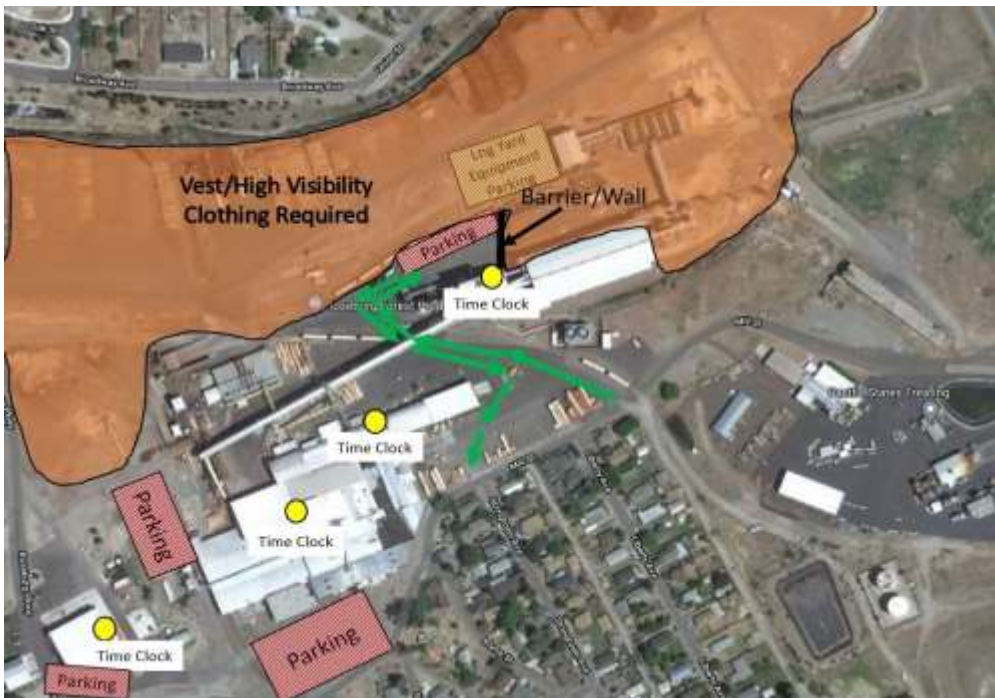
Graphic of the solutions developed by the cross functional team addressing log yard traffic.

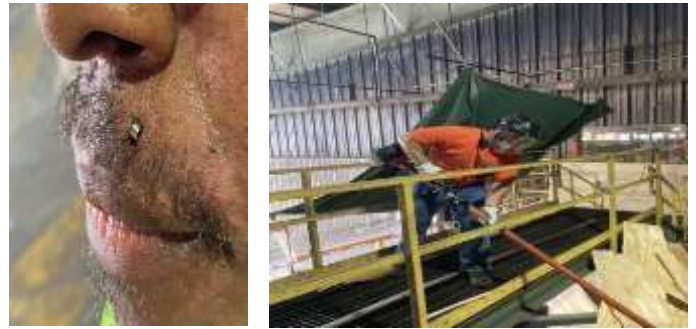
TM was using the plug up saw to cut veneer that had a tube in a bind. As he was cutting the saw blade came in contact with the tube in the dryer and broke off a piece of the blade sending it towards the PTM. The small piece of metal imbedded into the PTM's upper lip. It was removed by the HS nurse and TM returned to work without issue.

- *TM stated he was wearing all required PPE.*
- *TM was cutting veneer inside the dryer and the blade came in contact with metal and broke a tip of the blade.*
- *Incidents immediate causes are:*
- *Metal on metal contact between the blade and a tube*
- **Corrective Actions: (1) Review of incident with all shifts. Emphases with team about proper cutting procedures in plug ups. (2) Mandated the use of a face shield when using the plug up saw as shown in 2nd picture above (3) Discuss with leads of communicating and monitoring team members when in plug ups and the Face Shield is being used for proper safety gear to prevent injury.**

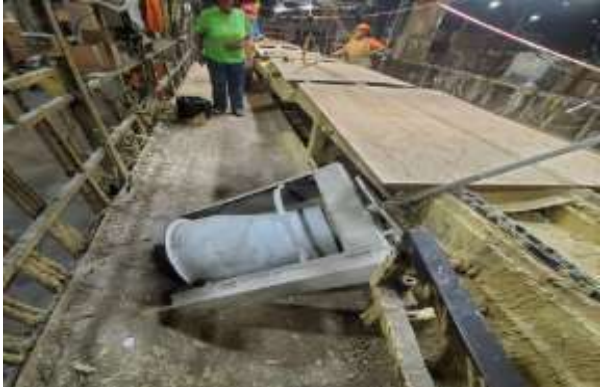
Sonic Air Fan Fell from Ceiling

At 12:15 am on Patch Line # 2 a Sonic Air fan fell from the ceiling landing on the operator side catwalk. No one was hurt and the fan was safely removed from the patch line. Dalton Baker took possession of the fan, it appears the all thread broke and as the fan fell the safety cable or support cables broke also. The fan landed on the catwalk approximately 5 to 6 feet from a TM that was patching. This is directly in line with TM's patching area and exiting the patch line work area.

- TM's working at Patch Line completing normal tasks required at the time of the incident.
- The fan fell within about 5-6' of the nearest TM.
- Initial investigations show immediate causes are: Structural failure of the fan mounts and cable attachments.
- **Corrective Actions: (1) Review of incident with all shifts (2) Complete Near Miss Form (3) Shut Down Sonic Air Fans within department – facility as necessary until deemed safe for operations (4) Conduct LL / RCA of the incident and share across the facility**

- Plant: Chopin Plywood
- Event: Sonic Air Fan Failure – Fell From The Ceiling
- Timeframe: Friday – May 21st - 2021
- High Potential Near Miss
 - Sonic Air Fan Fell From Ceiling – Landing on Patch Line Catwalk
 - Main Support Structure and Safety Cables Failed

- *TM's working at Patch Line completing normal tasks required at the time of the incident.*
- *The fan fell within about 5-6' of the nearest TM.*
- *Initial investigations show immediate causes are:
Structural failure of the fan mounts and cable attachments.*

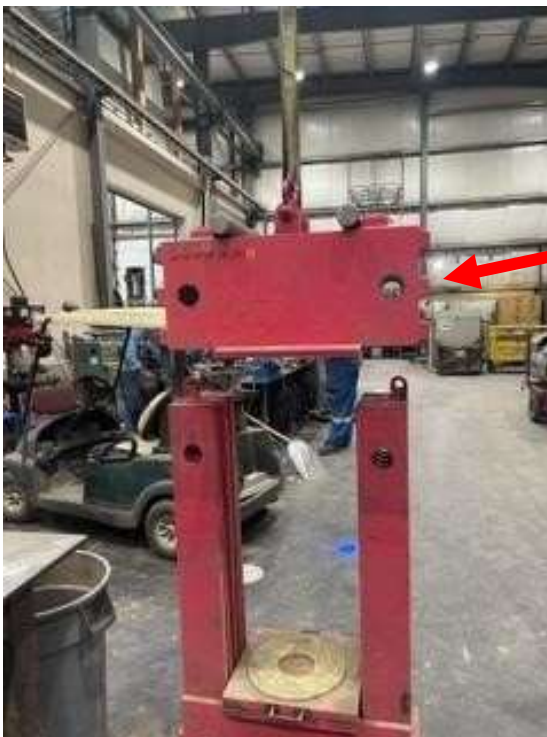
In early 2021, a mechanical engineering co-op student, Moez Khadim, and some maintenance crew members designed a testing bench that could test cylinder seal pressure of up to 660,000psi. Eric Knudsen (welder) fabricated the testing bench, and a professional engineer approved the design. The bench consists of a platform, frame and cap whereby the cylinder is hoisted onto the bench and the cap is pinned in place.

The cylinder is then pressurized with a portable hydraulic ENERPAC to test seal integrity.

The testing bench has a cap that is secured by pins. A crane is used to take the cap off, and then to position the cylinder inside the bench.

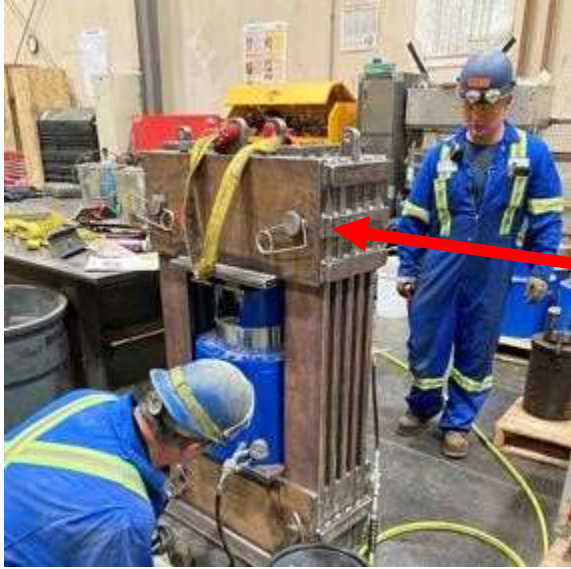
The crane is then used to place the cap back on, and the unit is secured with safety pins. The bench is then pressurized using a portable hydraulic ENERPAC unit. Dwight McGlynn and Mitchell Raymond work on developing a testing process.

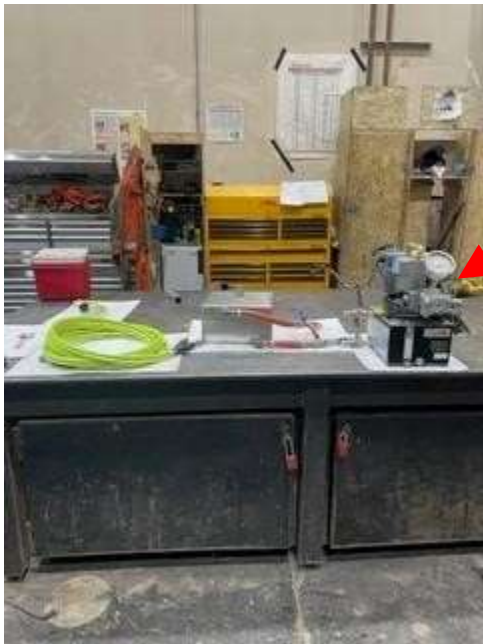
The bench is then pressurized using a portable hydraulic ENERPAC unit.

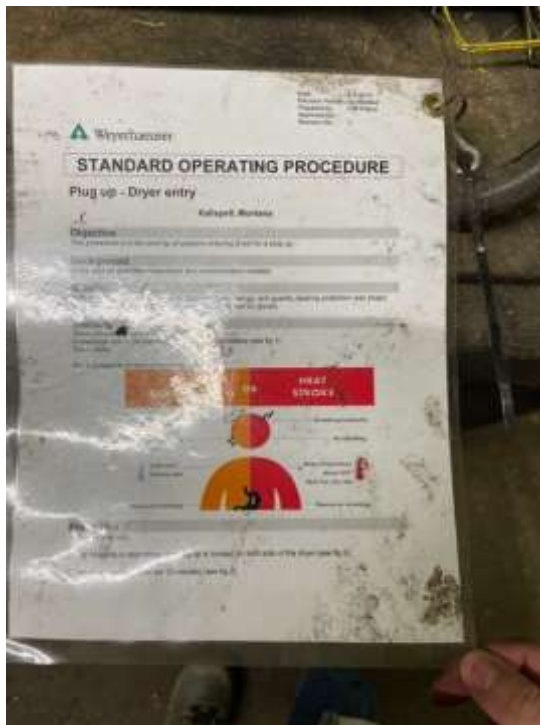
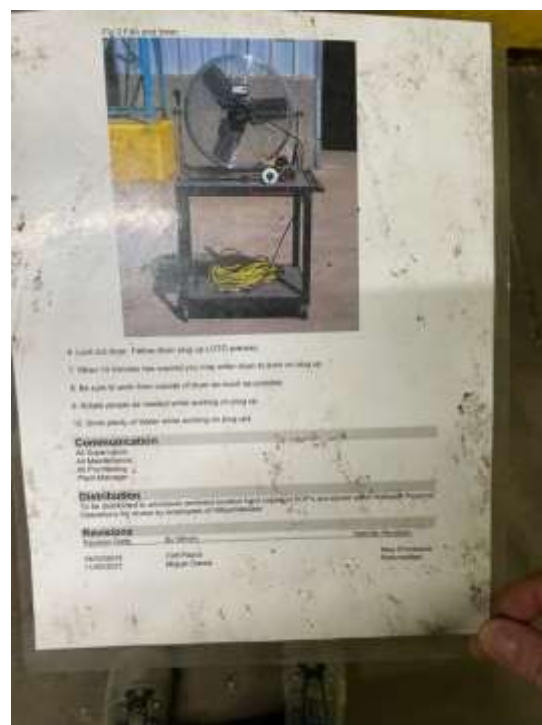
SOP attached to the cart for understanding and execution

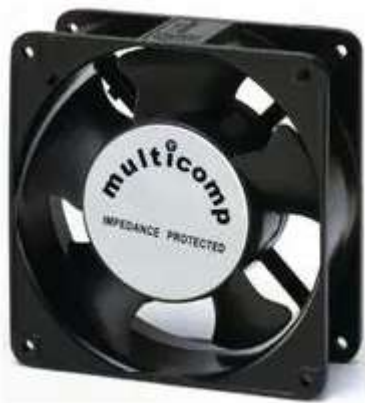
Multicomp Fan

This was a joint effort spearheaded by our dryer crews. With the help of the safety department, electrical and maintenance team, we were able to fabricate this system and have it installed on our dryers. Not only is this system extremely efficient in identifying fires or fire conditions early, but it was also extremely cost effective to install. We were able to install this system on both of our dryers and the process took less than a week to complete for less the \$5,000 in parts in labor to do inhouse. We used a Lorex model MC7711 camera, purchased off the shelf from COSTCO; Silicone was on hand with our site; and fan model was a Multicomp MC19684 AC 115 V 0.26/0.24 A fan.

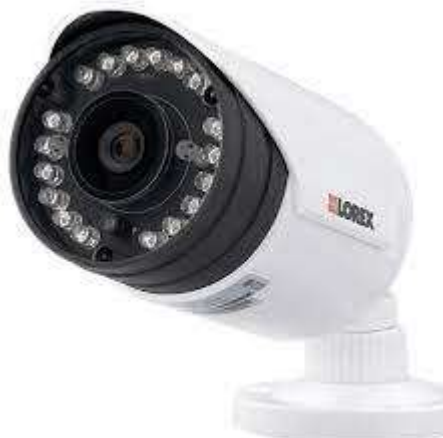
Lorex Night Vision Camera

At our dryers, we wanted a way to be able to detect sparks and smolders as early as possible in dryers. Historically, fires usually start at the floor area and by the time they are detected with process controls and other means, the fire is well established. We came up with the idea to use a night vision camera. We modified the camera using silicon to black out red light and installed a fan to the system to ensure the ambient heat does not ruin the camera. This was mounted this system in the middle of a hollow tube covered by high temperature glass, with metal shades fabricated to the system to keep light out of the system to ensure the camera remains effective. Sparks, flames, and smolders show up as white light on a monitor in direct line of sight our dryer crews in the control shack.

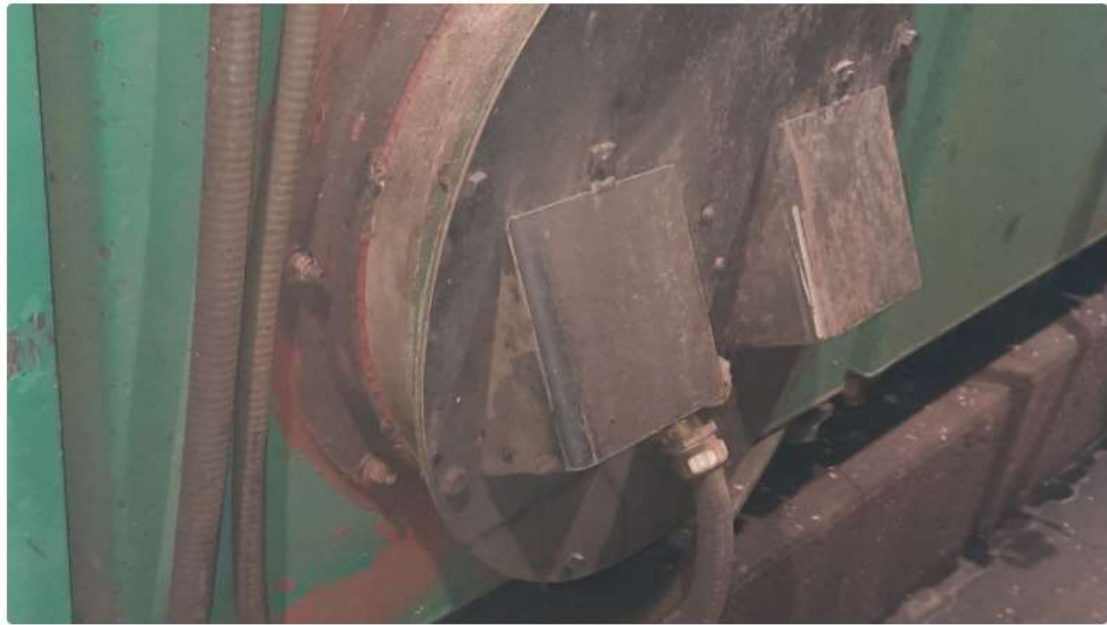
System installed on the Dryers

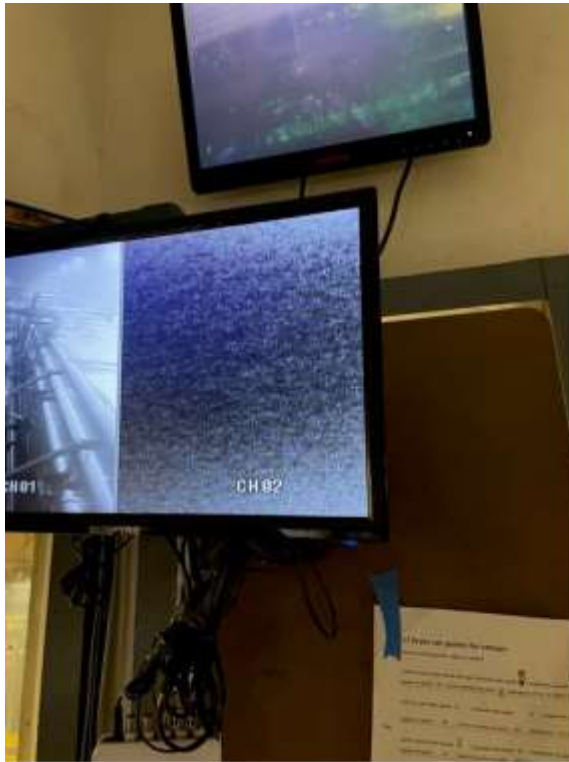
Camera Feed to Dryer Shack, White Hot indicates Fire/sparks

Since installation in early 2020 our two camera systems have detected over 25 fires/fire conditions that resulting in zero injuries and zero equipment damage by being able to respond immediately to the situations. This system can be easily replicated with other sites. Not only does this allow for early detection to allows us to use our mist fire suppression system, often times this does not prevent us from stopping production or potentially damaging our equipment and veneer by using our deluge systems to fight a larger fire.
