The following Good Safety Practices were developed from the Innovation in Safety Award submittals.

2021 Reports

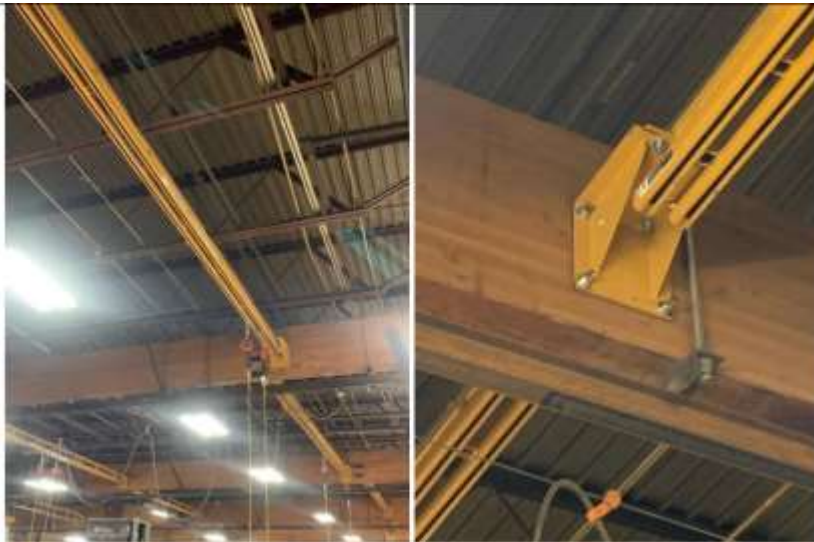
The mill was forced to find an option that would keep our associates safe and not stop production, we landed on a recessed and sectional fall protection system. The two-track system allows teams of two to tamp and tighten down bolts while providing fall protection for all associates involved in the evolution.

The vendor was brought back after the installation was completed to conduct multiple crew trainings as part of the commissioning process. The crews were issued harnesses and taught how to wear them properly. To remove any possibility of associates violating the OSHA regulated four foot height, the crews decided on a rule of two or more lockups high requires being strapped into the fall protection system.

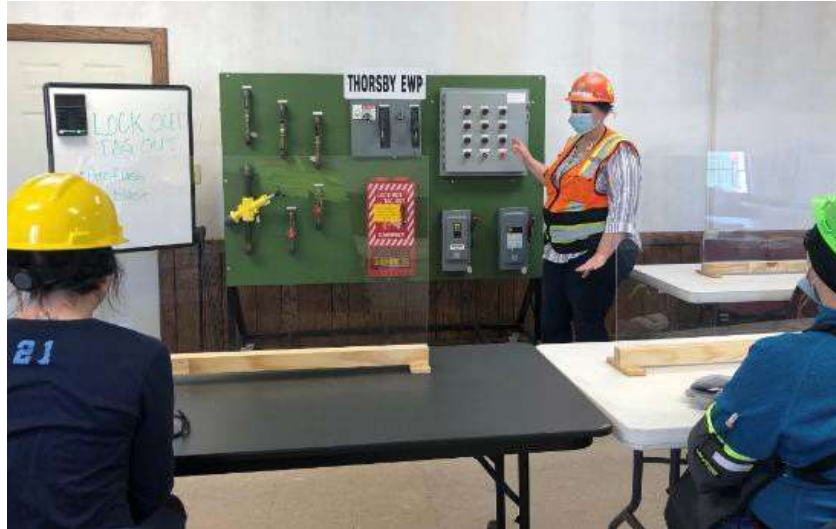
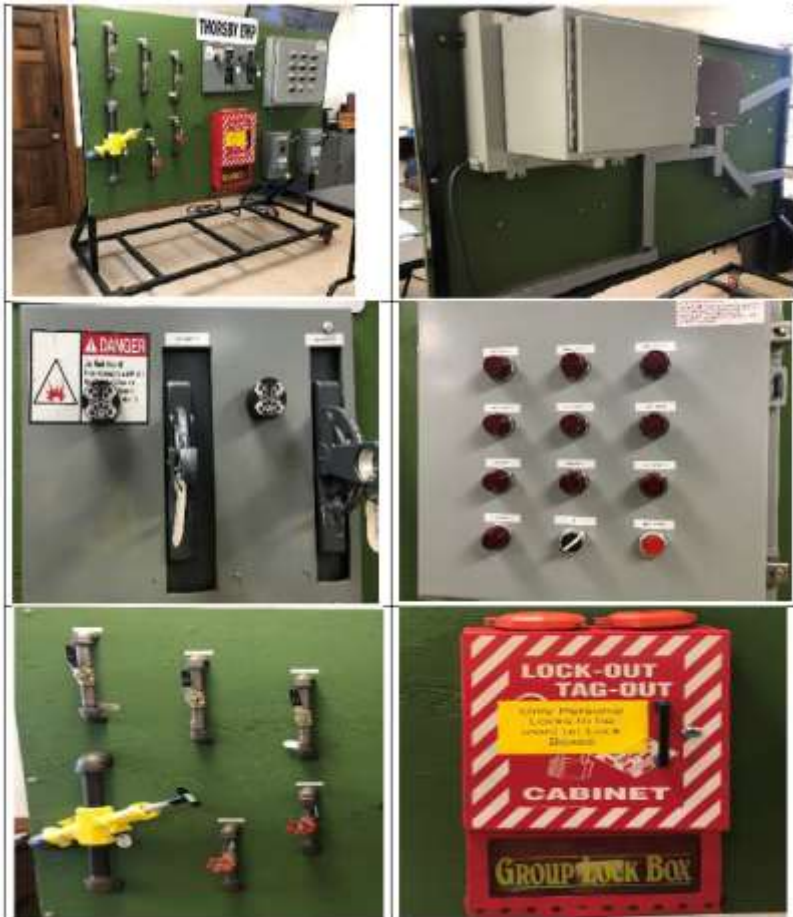
Our millwrights started to assemble / build the frame and attached the plywood when their scheduled allowed them time. The committee members met again to decide where to position all our lock point components (manual valves, disconnects, control panel, lock box). Between the millwrights and electricians, they figured out unique ways to install small limit switches hidden behind the manual valves. Once the valve handle is in the off position the limit switch is made which feeds the signal to a small PLC. This gives us the ability to program different lock-out scenarios.

New hires are now using the tool during orientation. The lock-out board is also used as a training tool to teach employees where to stand to help minimize the safety impact should an arc flash occur. Some supervisors are using the board to complete annual refresher training. With help from our millwrights who built the frame and attached all the lock-out points and the electricians who completed the wiring and program all while using input from members of the safety committee this program has been successful.

The biggest improvement is giving employees an advantage to learn how to perform lock-out tag out while in a controlled environment with an instructor present. In this environment mistakes would not lead to an injury. When a newly hired employee starts his or her shift, they already have some exposure and it helps lower our risk involved in lock-out tag out by giving the added safety awareness. When a new team member is trained how to safely perform a lock-out they have some knowledge to recognize when a peer is not following procedure and can potentially intervene. We stress safety interventions and it's a big part of our safety culture.

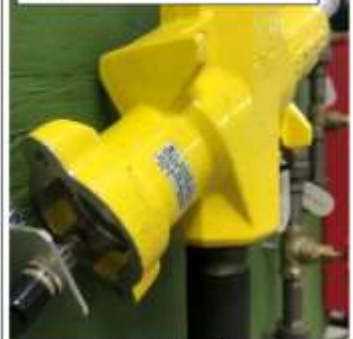
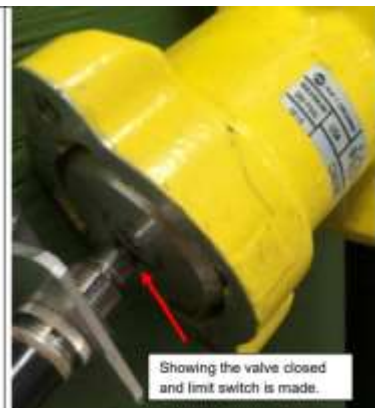
Showing the valve closed and limit switch is made.

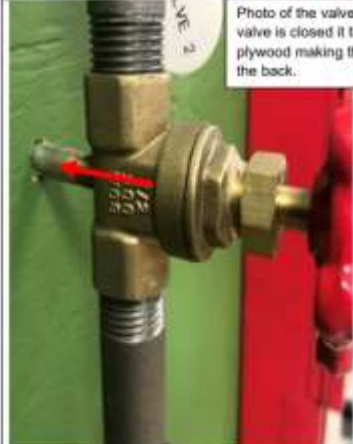
Photo of the valve modification. When the valve is closed it threads through the plywood making the limit switch located on the back.

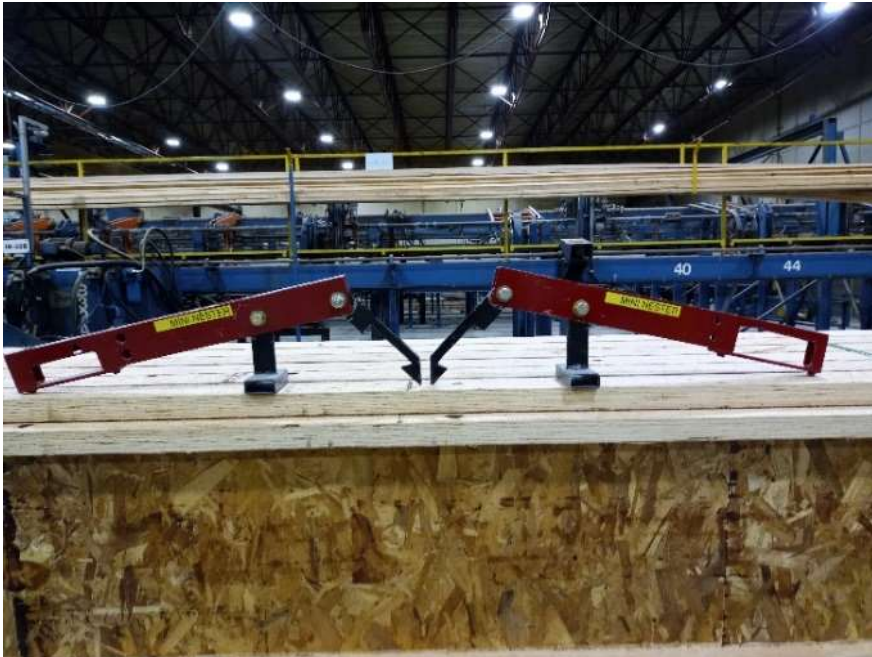
Here is the miniature nester:

We place the miniature nester on the I-joists bundle. We use it to raise I-joist and place it at the right location

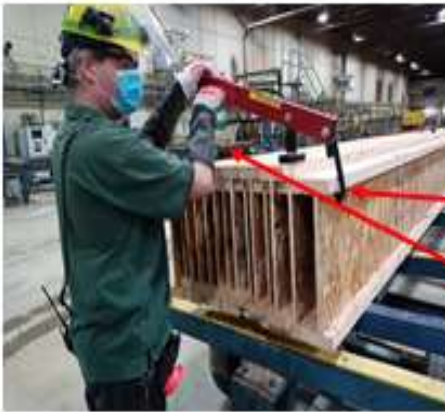
Hook creates leverage effect

With the hook and the leverage effect, I-joist comes easily at the right place it has to go.

After a safety near miss reported with I joist manipulation at the rework station outside in the yard, the team chief has imagined a simple and compact leverage concept. With the help of a mechanical employee they developed the miniature nester. A yard operator also has joined the innovation team to help them to test the new tool. They tested their tool to repair a bundle of 20 inches depth and 60 foot long I joist bundle, which is near the worst case scenario in terms of weight.

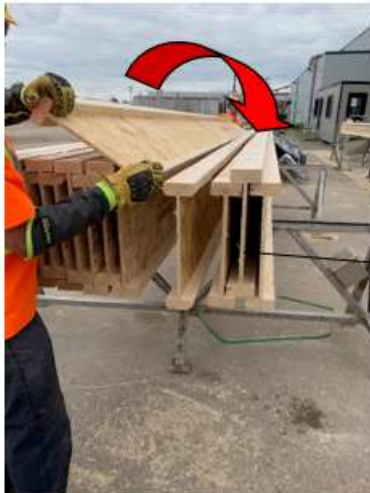
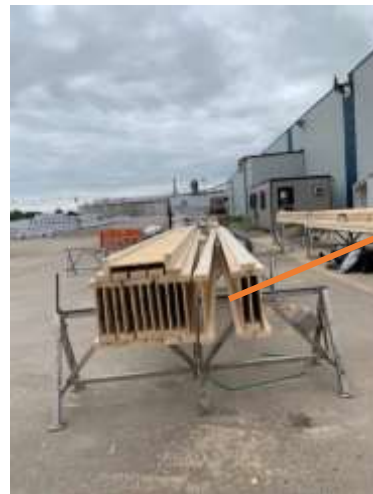
Previous procedure to insert an I-joist in a unit:

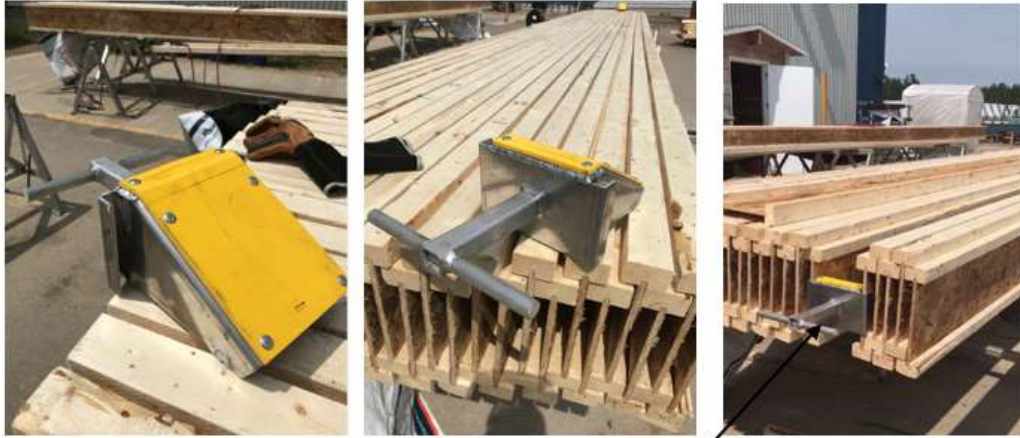
Tool created to provide enough space to insert an I-joist without putting hands and fingers in the area:

The tool makes sure there is always the right space to insert an I-Joist. No need for the employee to create the space by himself with his hands.

With the use of this tool, pinching and knocking hazards are gone. Workers do not have hands right in the process. Since the use of the tool is required, there hasn't been any other injuries at this workstation,

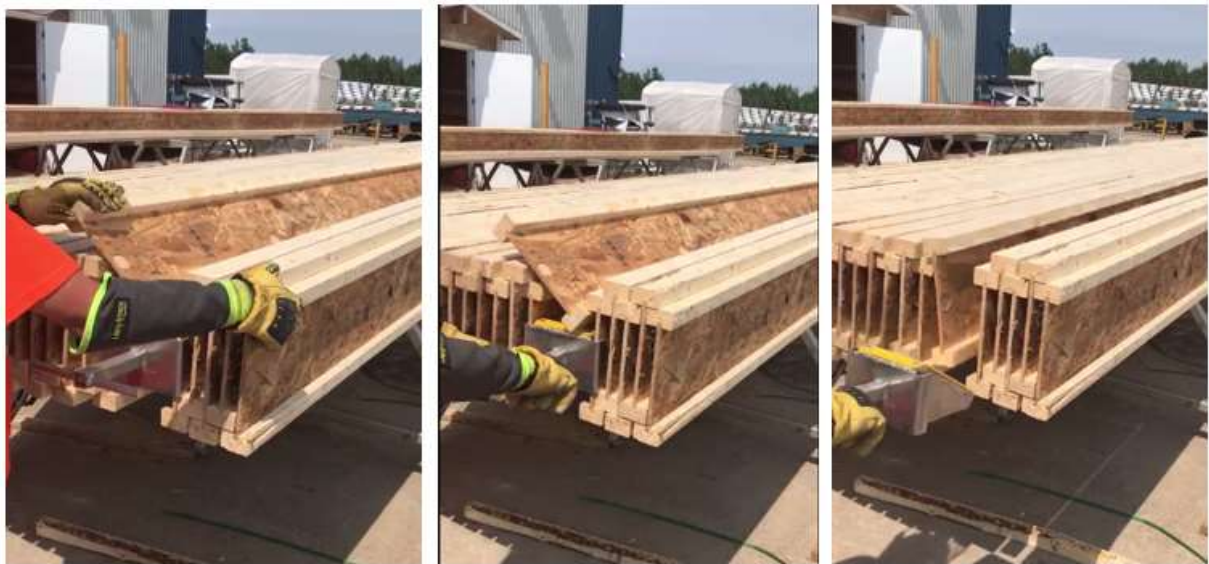
I-joist only needs to be slide on the tool. No pinching hazard. Employee takes the tool with both hands. He pulls and the I-joist get at the right place without knocking. Hands are off the potential danger area.

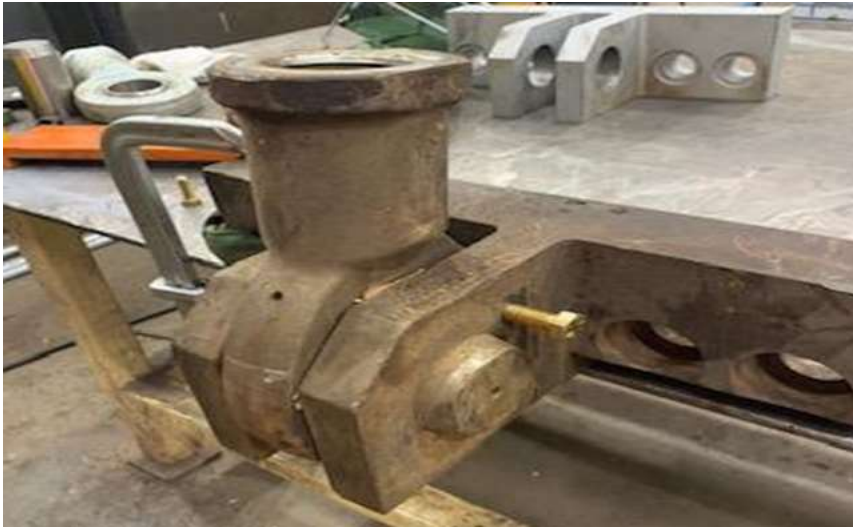
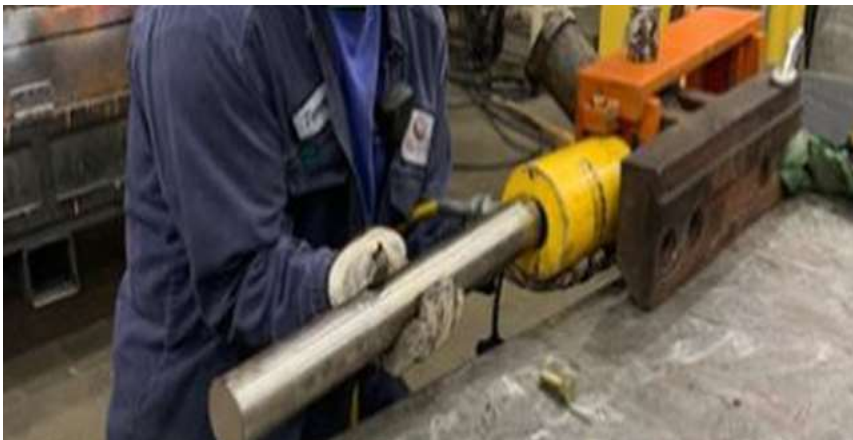
A millwright at Oakdale specializing in hydraulics and press maintenance identified the need to come up with a device to improve the safety of the job task to remove pins (Pic#1) from arms to the press. There are 4 arms (two on each side of press) with 13 large diameter pins at each level, holding the arms on the press. Team members in the past had to put a 30 ton port-a-power (hydraulic ram) on the end of the pin, then hold a backup pipe (one person having to hold both at the same time due to space limitations-Pic#2).

The millwright at Oakdale that specializes in hydraulics and press maintenance came up with the idea after becoming concerned about the positions team members were put in to take out the pins and the time it took to complete the task especially in summer time when team members are exposed to higher temps around the press and cutting down the time a task takes to complete is very important for team member safety.

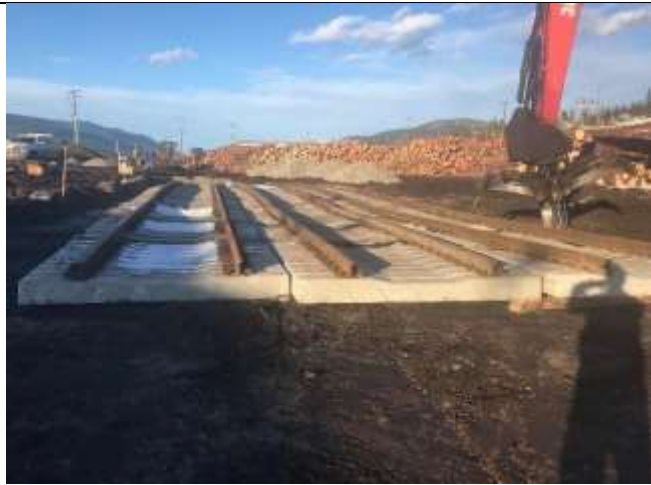
Concrete Rail Tie Sections

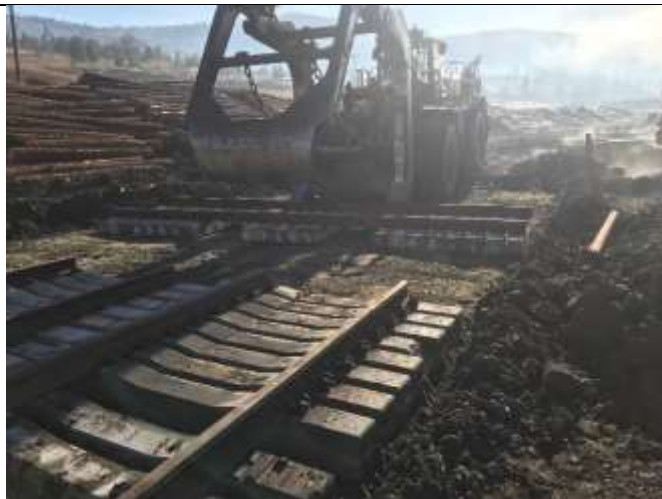
Loader Placing Rail Tie Sections

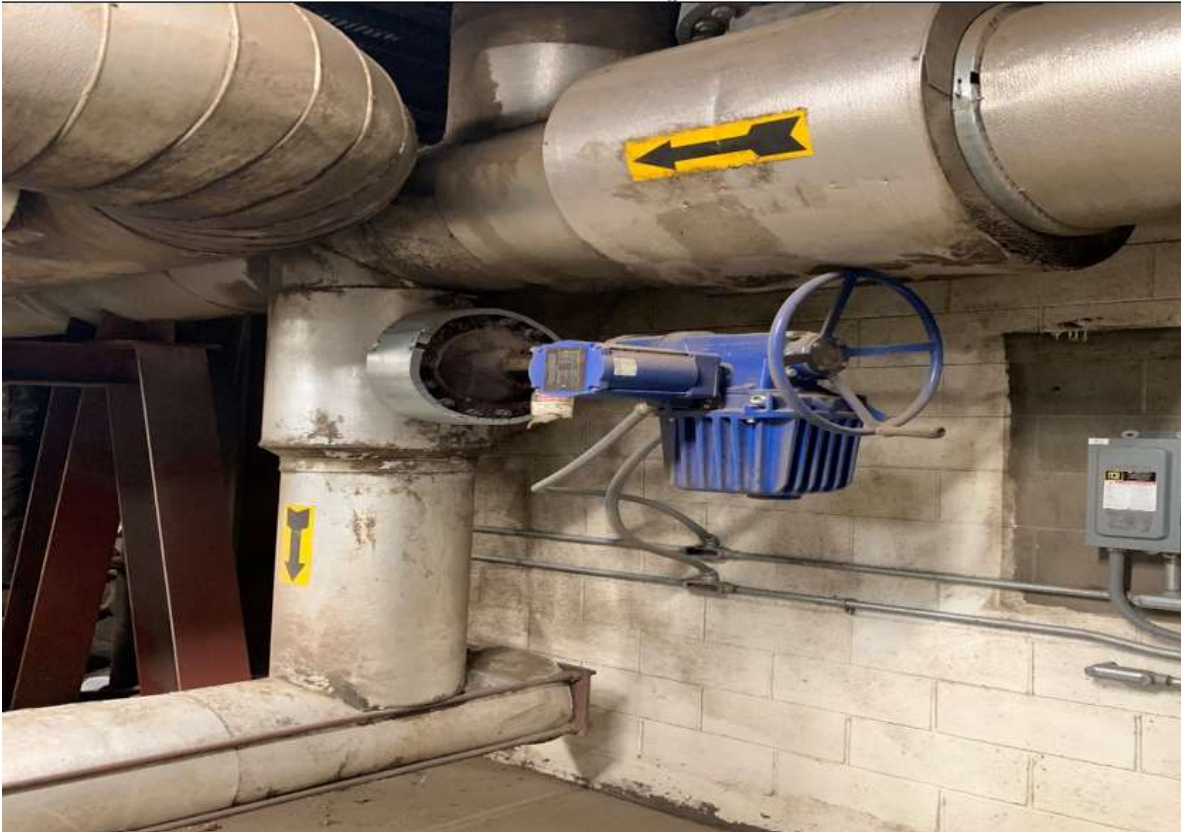
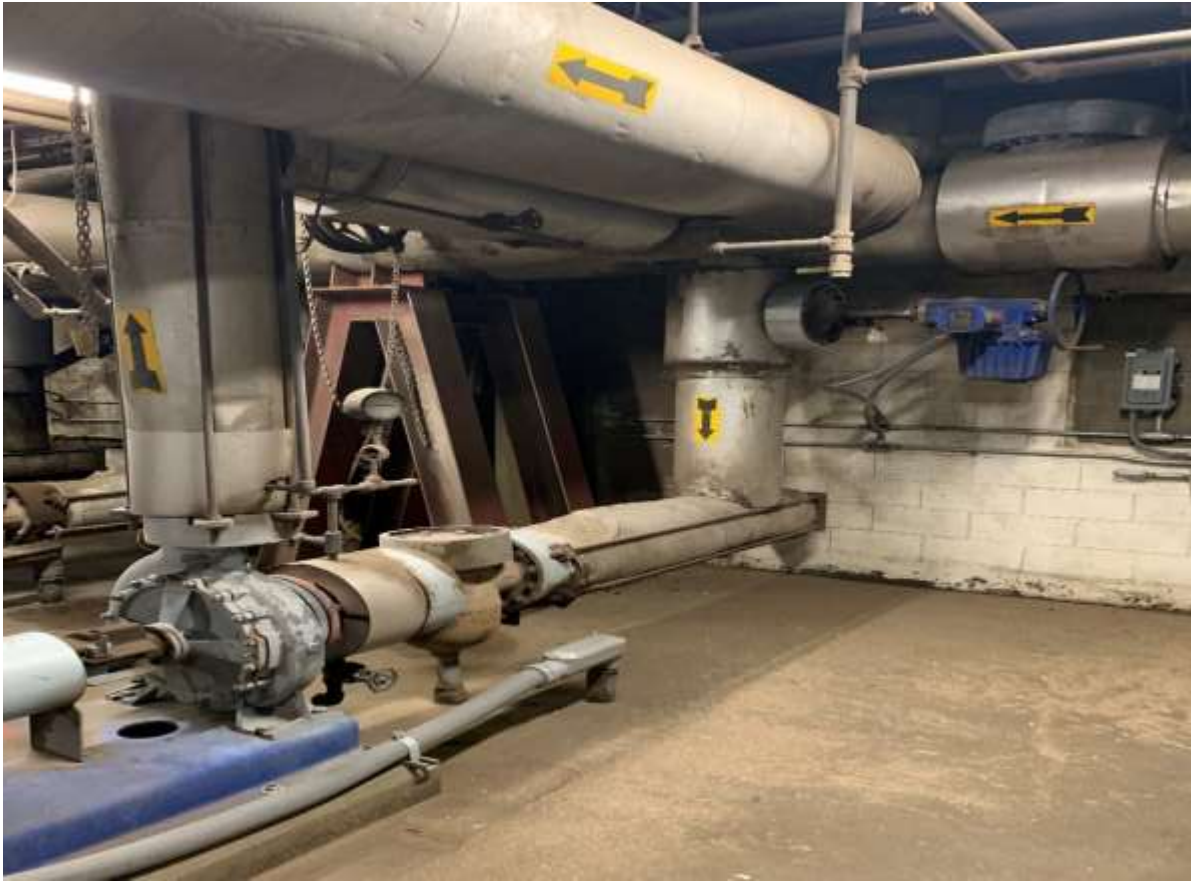
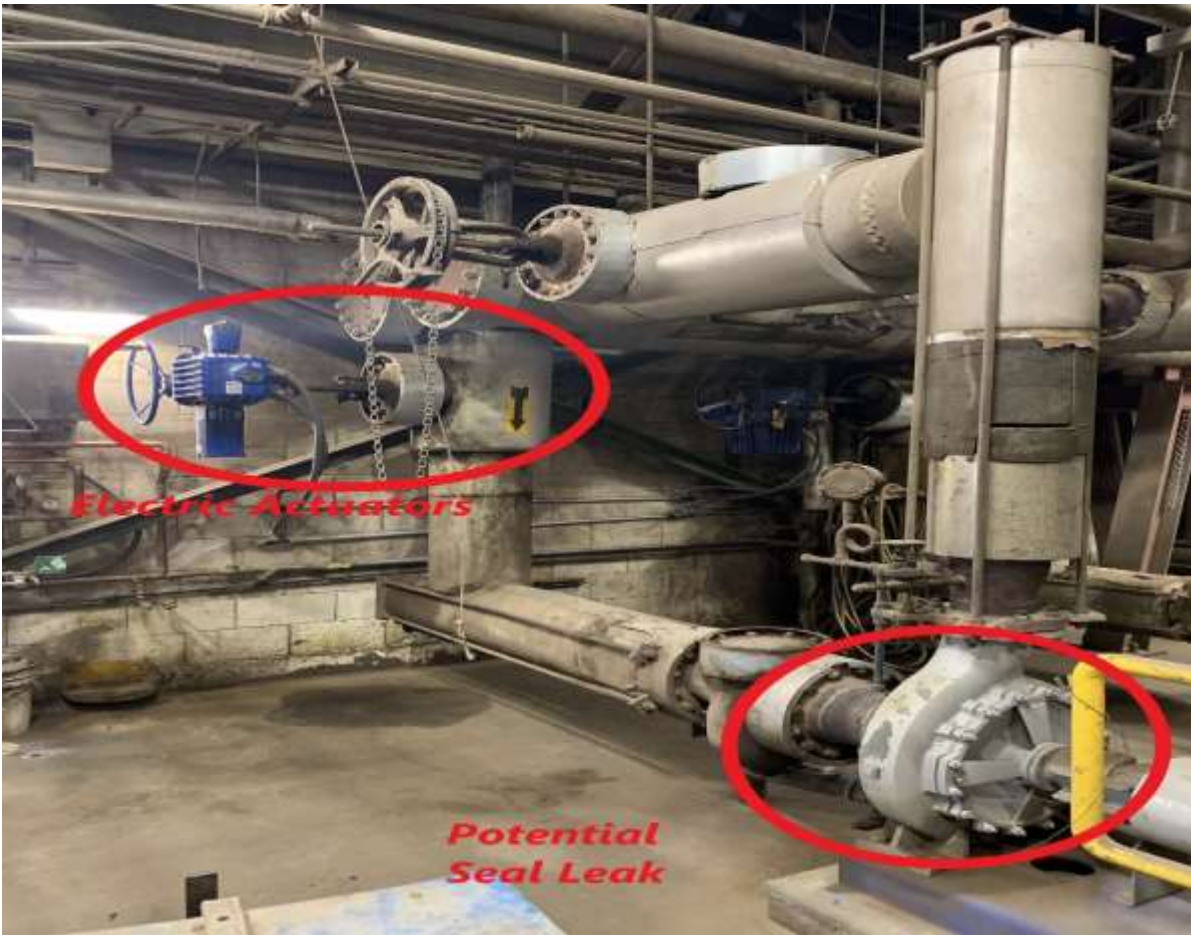
Installation of electric powered shut off valves for hot oil primary pump inlet piping

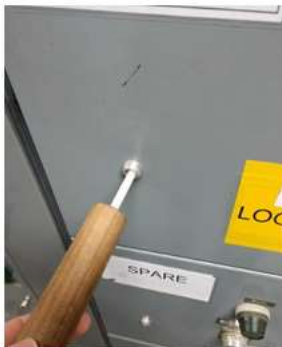
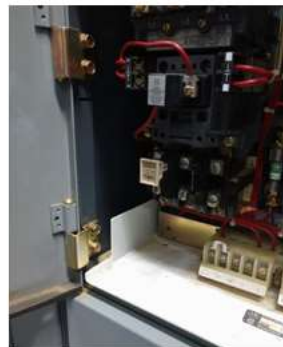
- The reset tool was fabricated to help reset the heaters, without having to open the bucket. This eliminates many potential electrical hazards of getting in the bucket to manually push the “reset” button.
- A heater will trip as a safety feature, if it is running in an overcurrent for too long and will then require a reset. Once reset, there is usually no further action needed.
