Forklift Injury

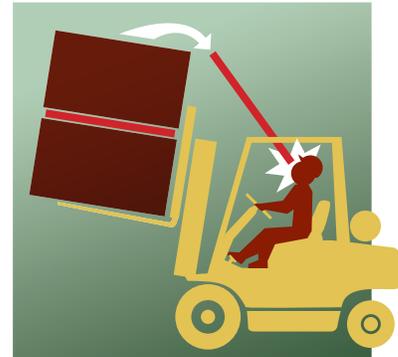
A forklift operator was stacking units of OSB in the warehouse staging area so product could be run through the T&G line the next day. The operator was moving the product through the plant to the warehouse. As the operator stacked the two units on top of two existing units, the 2x4 center crossout (used to separate units) came off the top unit, and through the top roof guard (“headache rack”) of the forklift, striking the employee in the face, above the upper lip. The laceration required sutures to close.

Inventory practices of stacking material in the manufacturing areas creates additional required travel with unsecured loads. An opening in the headache rack of the forklift allowed the 2x4 to pass through. The crossout was warped, making it easier to move on top of the load, and the forklift was extended beyond the unit edge.

1. Retrofit forklifts with protective top covers that prevent a crossout from passing through.
2. Review inventory planning to ensure shortest route of travel.
3. Communicate to supply group so that this can be planned into future forklift purchases.
