## Cross-Laminated Timber Roof Panels at the Promega Corporation Facility: Documenting Installation and Monitoring In-Service Moisture Conditions

### Background

### Objective

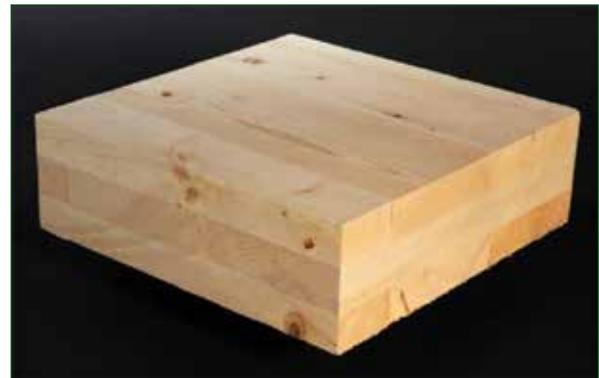
Example of CLT panel with three layers.

Cross-laminated timber (CLT) is a prefabricated solid engineered wood product made of at least three orthogonally bonded layers of lumber to form a solid timber panel intended for roof, floor, or wall applications. It is a highly “green” material that is made from an abundant renewable resource, sequesters carbon, has low embodied energy, and has excellent aesthetic, structural, and thermal properties. Although this engineered wood product has been used in Europe for over 15 years, the production of CLT and design of CLT structural systems have just recently begun in North America.

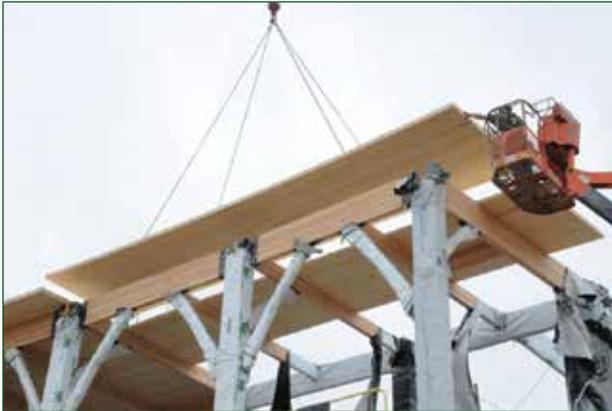
**CLT roof panel being lifted into place at the new Promega Corporation facility.**

Photographs and video have been taken at various stages during installation of the CLT panels. Wireless sensors were installed to measure wood moisture content, temperature, and relative humidity. Sensors were installed at various locations, on both the top side of the CLT panels and the bottom (interior) side. Sensors on the top side were installed shortly after CLT panel installation, prior to placement of a waterproof membrane and rigid insulation. Interior sensors were installed directly below the topside sensors.

and construction community, showcasing CLT used in a commercial building application. The CLT panels, composing the structural roof deck, are expected to exhibit excellent performance as part of a well-designed and constructed building enclosure. Moisture and temperature conditions are expected to be stable and close to typical values for wood members in the building interior. Measurements will provide documentation of actual performance.

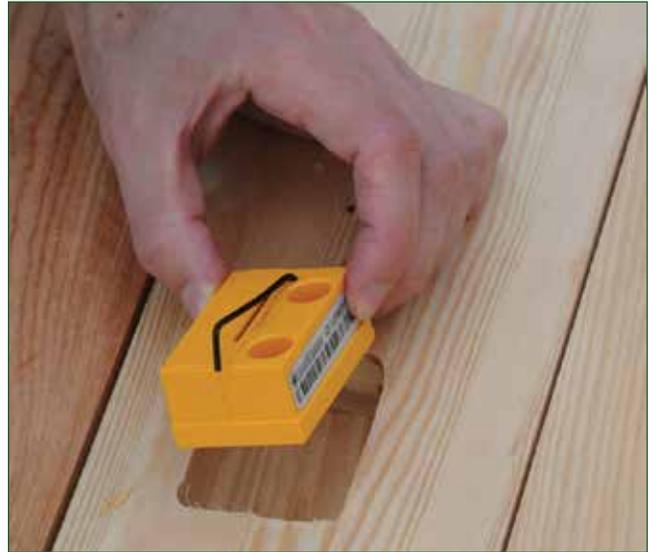
**Wireless moisture-temperature sensor being installed in a CLT panel.**
